Situation Photo Log

Thursday, January 24, 2013

Kalamazoo River / Enbridge Spill

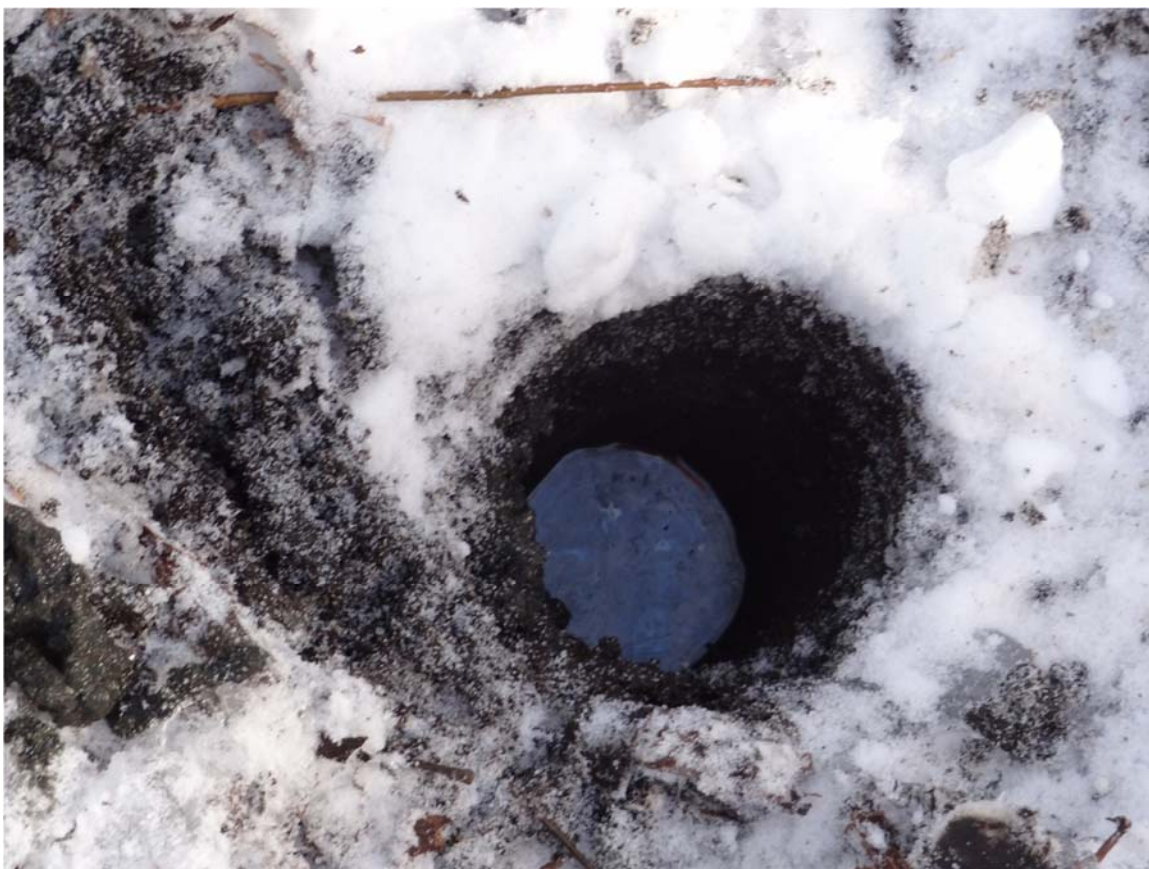
24. MP21.25 RDB overbank oxbow observed sheen in the boring hole.

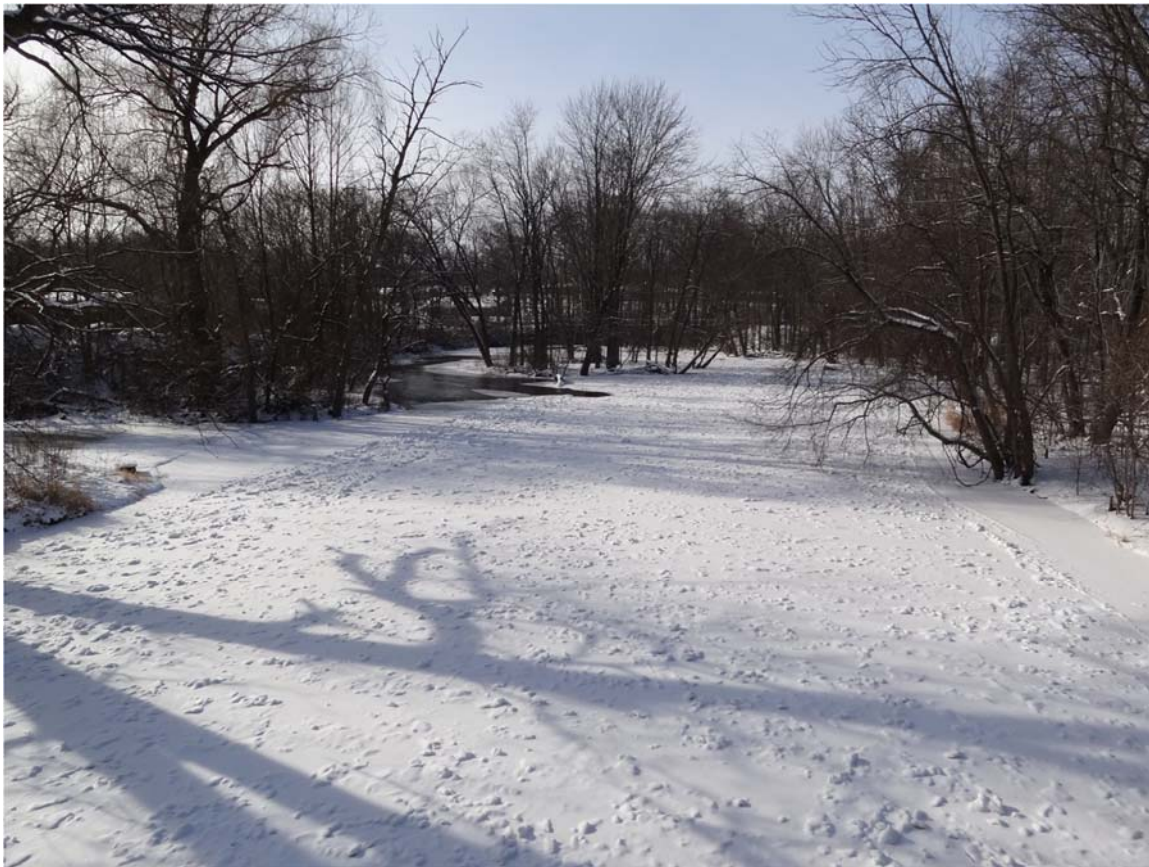
25. MP14.0 Beadle Lake Rd. Bridge downstream observed river icing conditions.

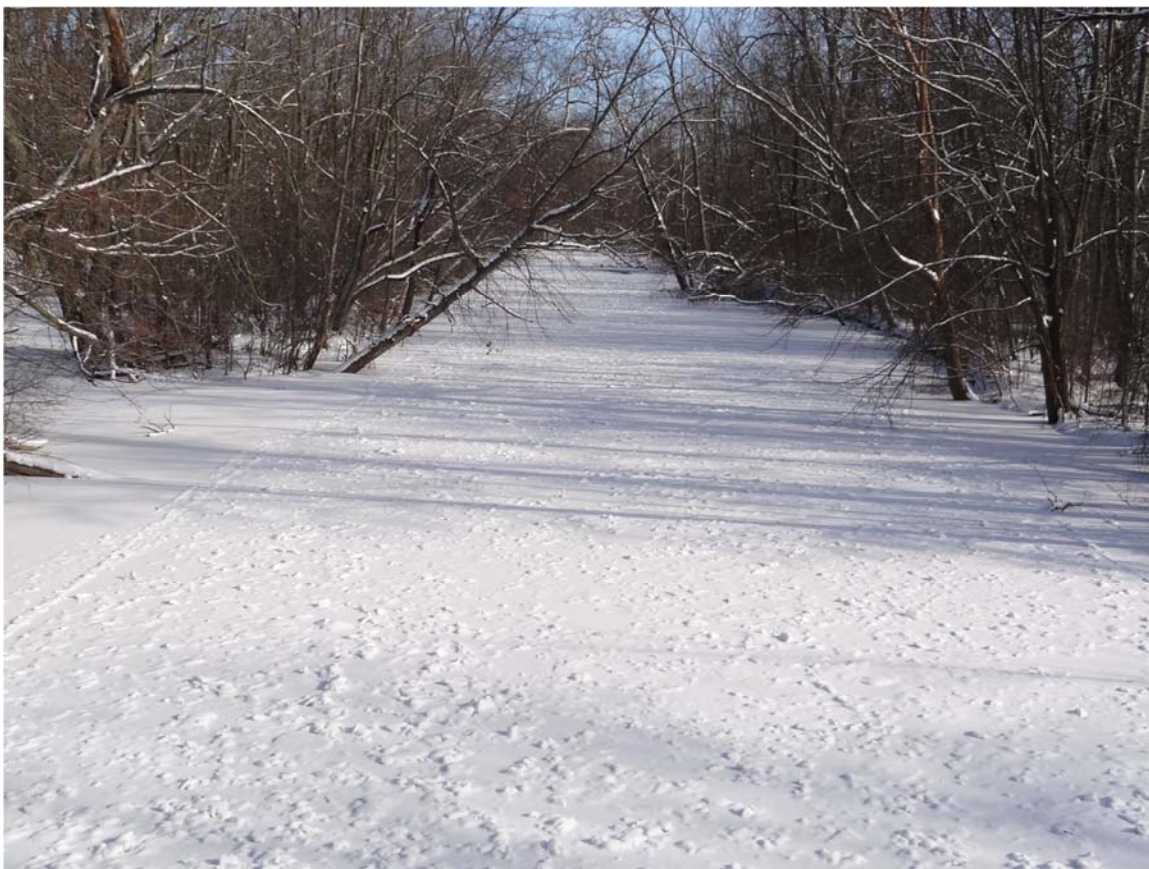
26. MP14.0 Beadle Lake Rd. Bridge upstream observed river icing conditions.
